Connecticut River Bacteria Monitoring Project

**FINAL REPORT
604b Project # 2009-13/ARRA 604**

**Pioneer Valley Planning Commission
Prepared by Anne Capra, AICP, Principal Planner**

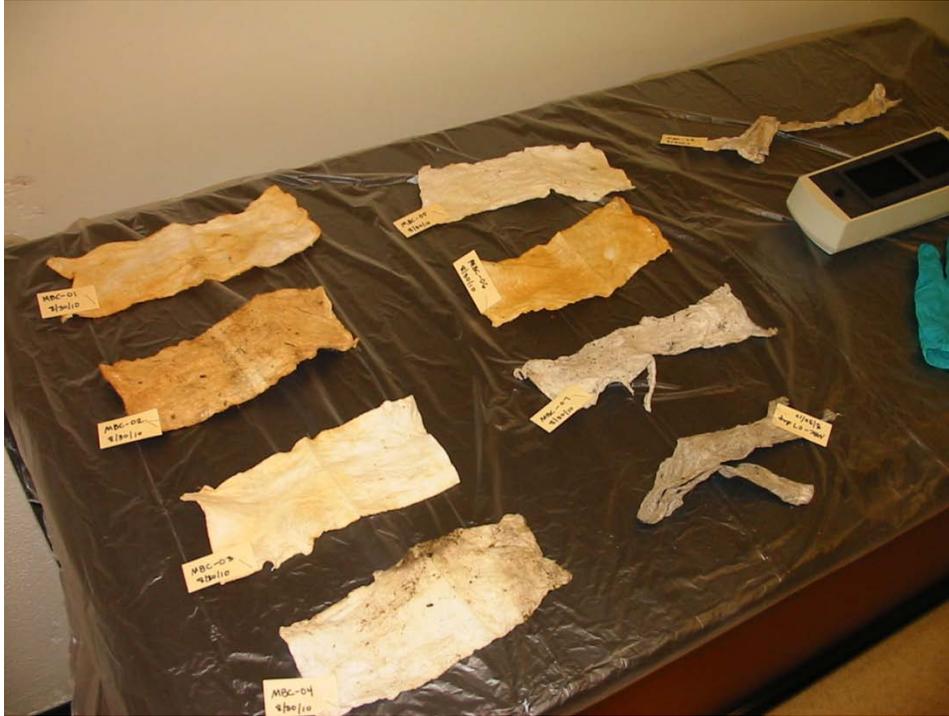
Figure 1. Dried optical brightener pads ready for analysis on September 2, 2010

CRWC completed a single round of optical brightener testing along the underground portion of Maple Brook in Greenfield. CRWC River steward worked with one of the CRWC volunteers to identify sites, place the pads in catch basins, and retrieve them after a period of four days. Standard operating procedures (SOPs) as identified in the QAPP were followed. White cotton pads without optical brightener from VWR Inc. were used. Pads were inserted into an 8½ x 12½-inch plastic mesh bag (typically used for vegetables or shellfish) purchased from Volm Companies, Inc. of Wisconsin. Pads were weighed down with small rocks, and the pads were stapled onto the mesh. The staples were determined to be inconvenient during the removal process. A bag with a pad was lowered down a

storm drain using fishing monofilament, and affixed to the metal grate of the catch basin by tying. Prior to going out in the field, all supplies and equipment were tested for optical brightener contamination by shining a black UV light over each item.

There was one clear “hit” at Garfield Street and one potential positive at Maple Street. During a meeting with the Greenfield DPW, it was determined that a red-stained pad found on North Street may have been due to a former rouge factory in that area. The DPW thought that all rouge sediments had been removed, and they planned on investigating this further.
